# **Record of Decision**

## **Dump Site Near Bldg. 293**

**NCTAMSPAC, WAHIAWA, OAHU, HAWAII**

**September 2006**

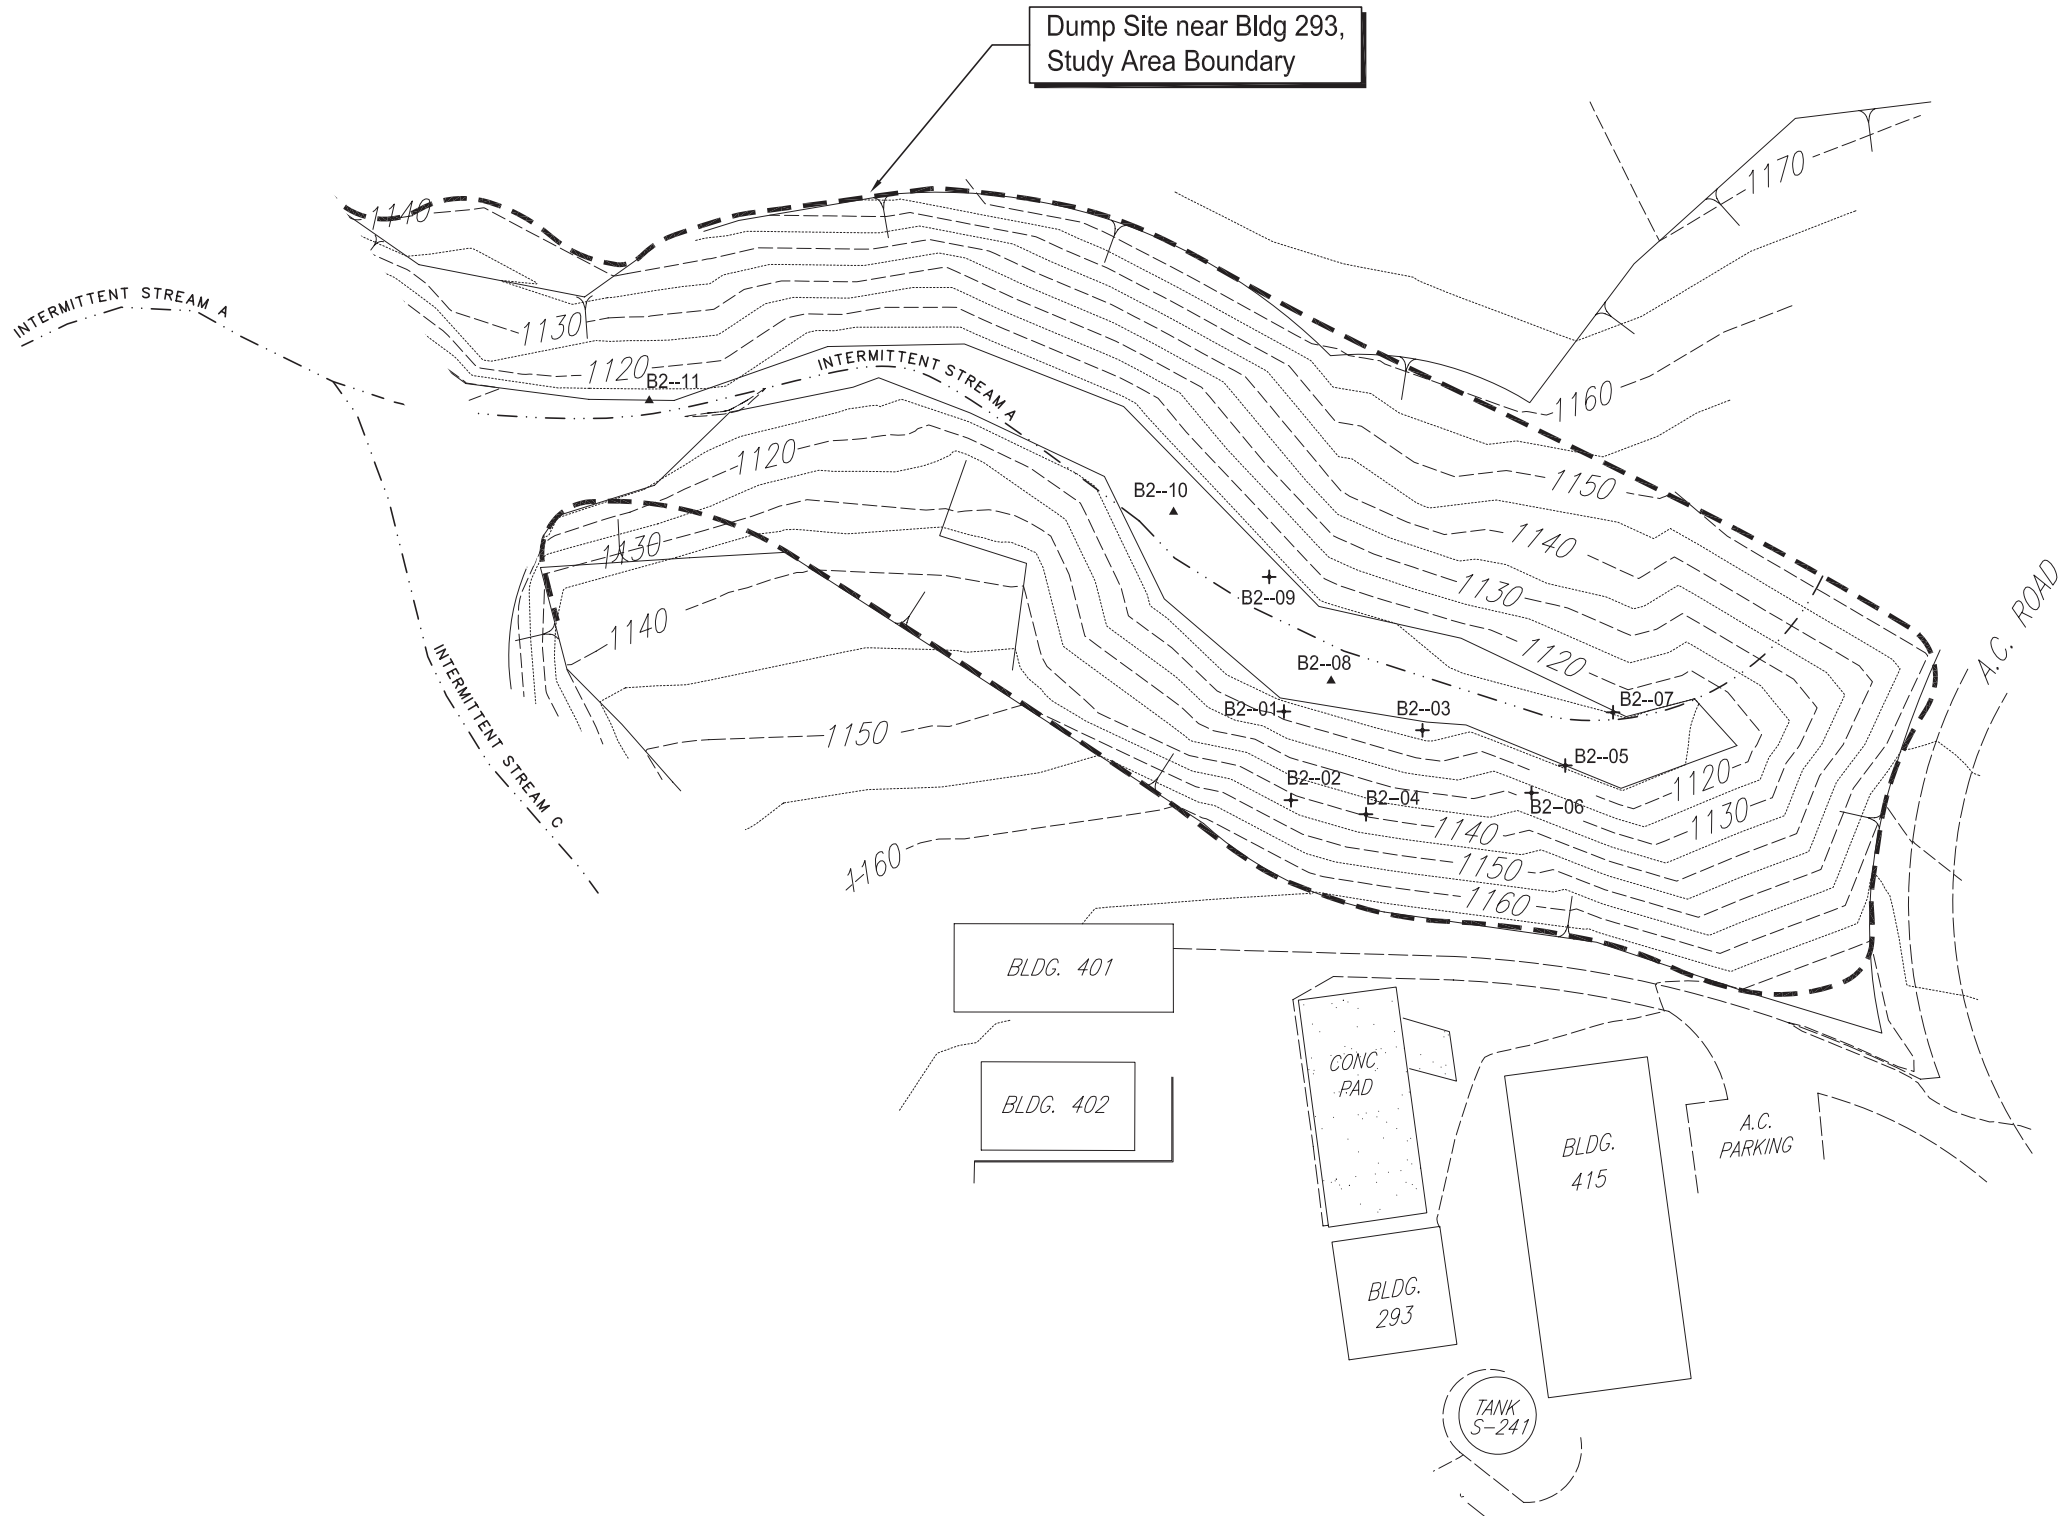
Figure 2  
Site Layout Map  
Dump Site Near Bldg. 293  
NCTAMSPAC, Oahu, Hawaii

As shown on Figure 1 (all figures are located at the end of the document), the Dump Site Near Bldg. 293 is located in NCTAMSPAC Wahiawa, Oahu, Hawaii. As shown on Figure 2, the Site occupies about 2.9 acres in a gulch next to the concrete foundation of Bldg. 293, the former Auto Hobby Shop, approximately 0.13 miles north of Whitmore Avenue. Existing and former warehouse building locations and parcel boundaries at the Site are also shown on Figure 2.

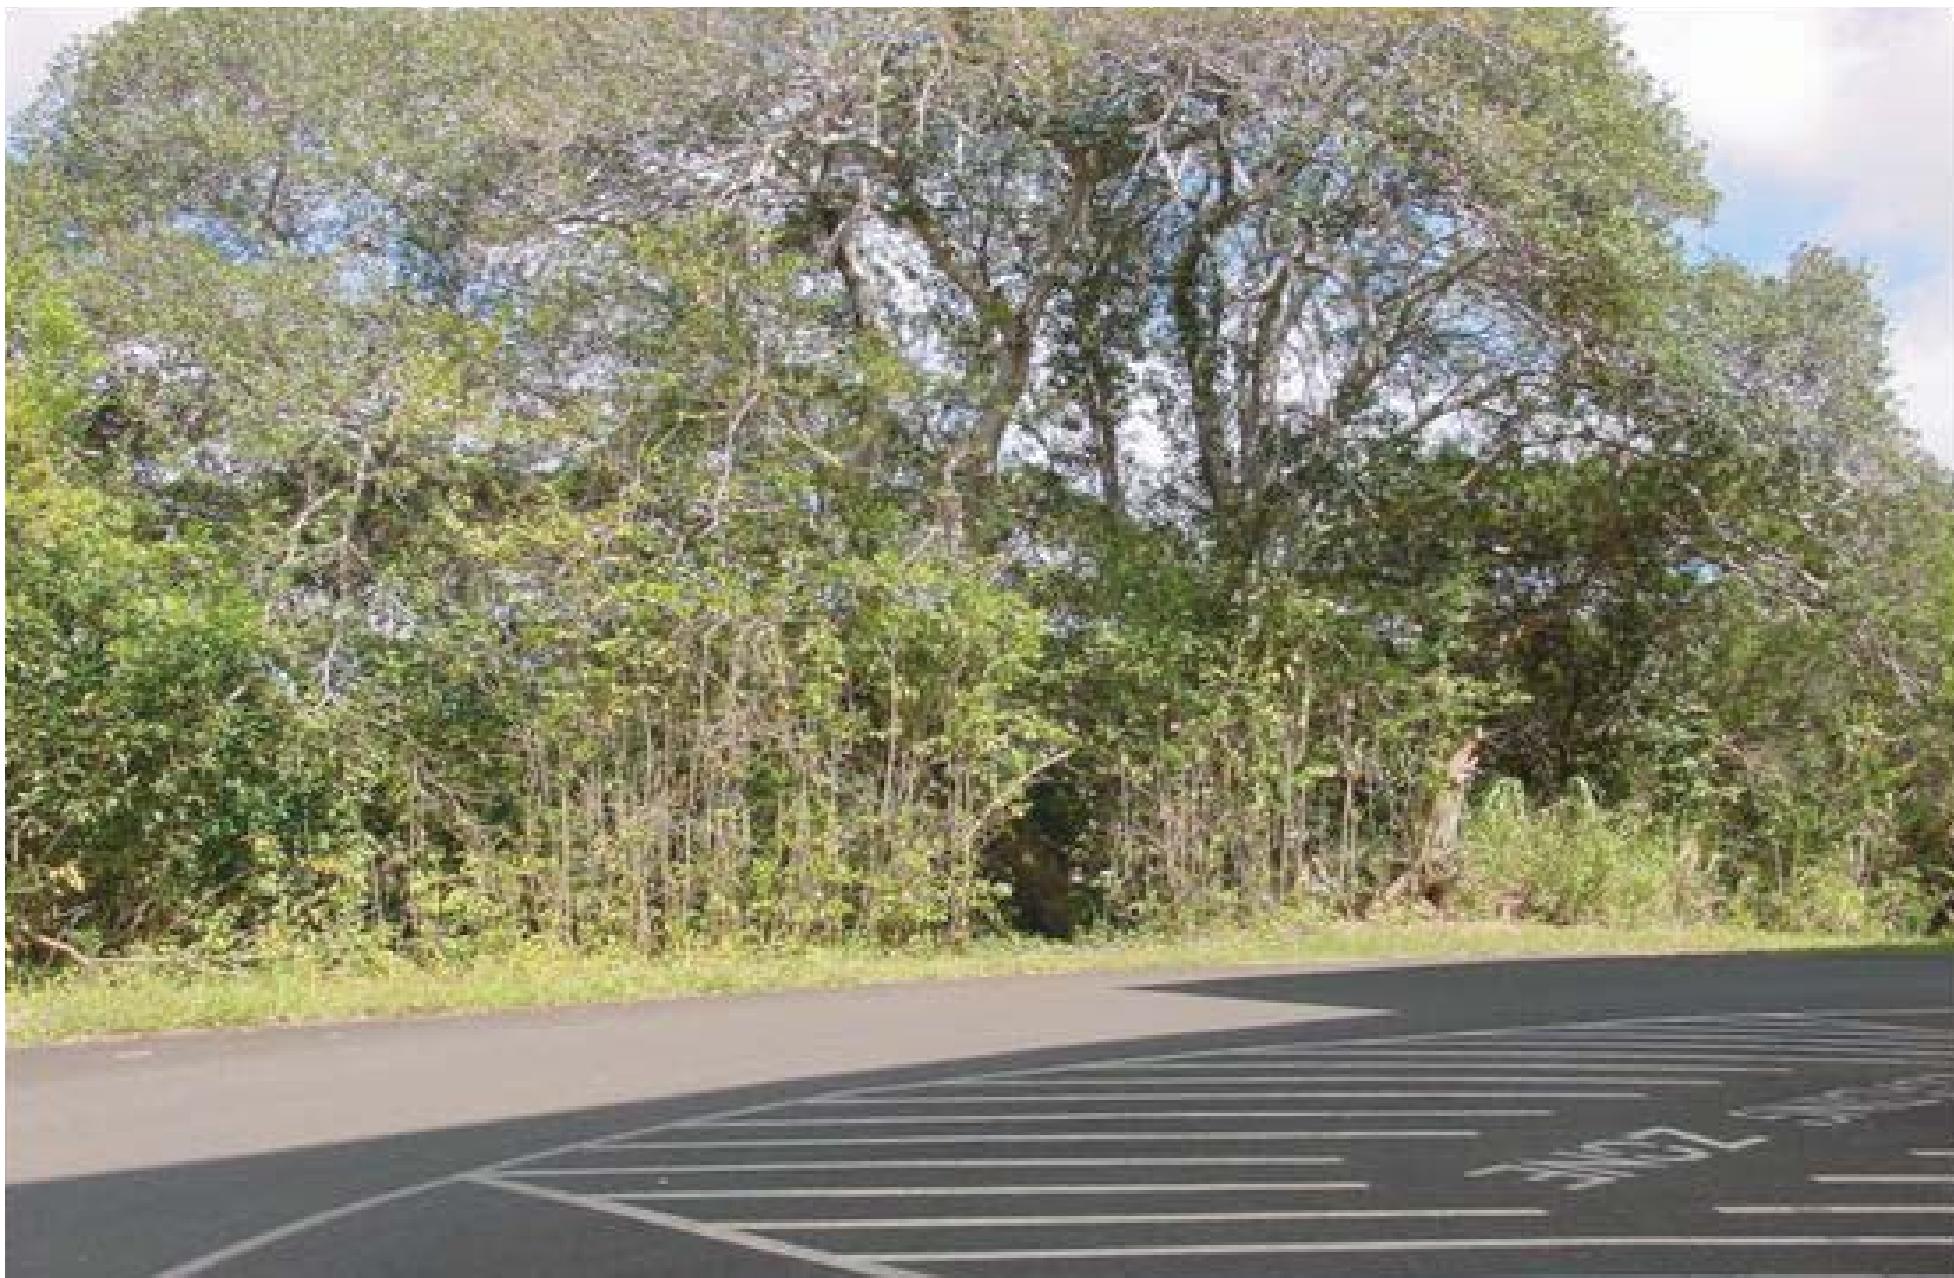
**Figure 3**  
**Current Site Conditions**  
**Dump Site Near Bldg. 293**  
**NCTAMSPAC, Oahu, Hawaii**

There are no activities currently at the Site. Current site conditions are shown on Figure 3.

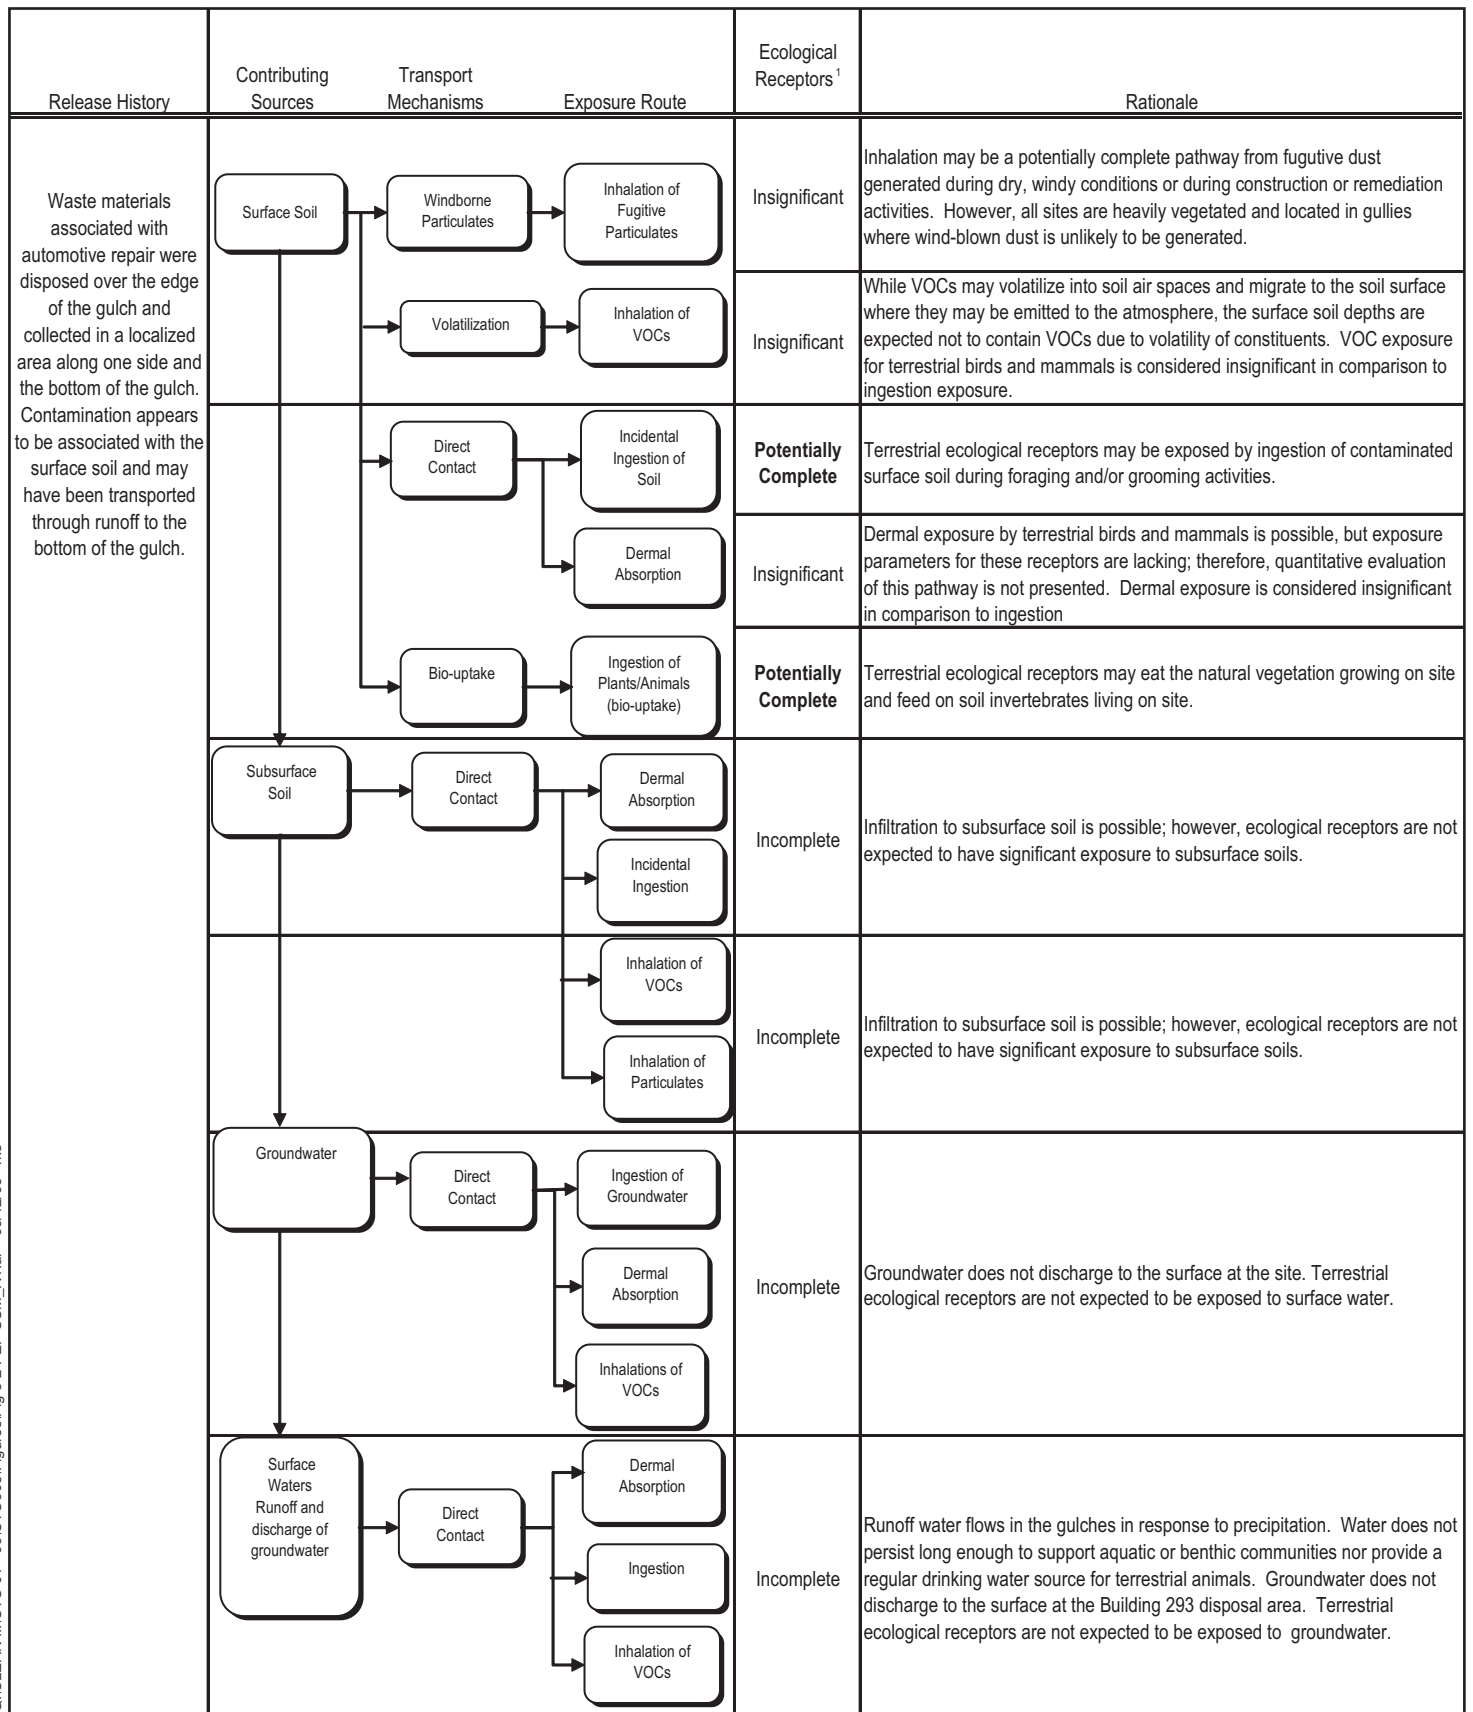
**Figure 6**  
**Ecological Receptor Conceptual Site Model**  
**Dump Site Near Bldg. 293**  
**NCTAMSPAC, Oahu, Hawaii**

(1) Future conditions are assumed to be the same as current conditions for ecological receptors. No future scenarios are run.

This conceptual site model (CSM) identifies land and groundwater use scenarios and potential exposure pathways for site-specific current and future land users and ecological receptors. Figure 5 and Figure 6 are flow charts of the CSM and represent the land and water use scenarios and how they may affect human and ecological receptors. Figure 7 shows the surrounding land use and locations of residential areas.
